PAMEACHA POND DAM
CT-00145

NATIONAL DAM INSPECTION PROGRAM
CORPS OF ENGINEERS

INSPECTION REPORT

PAMEACHA POND DAM

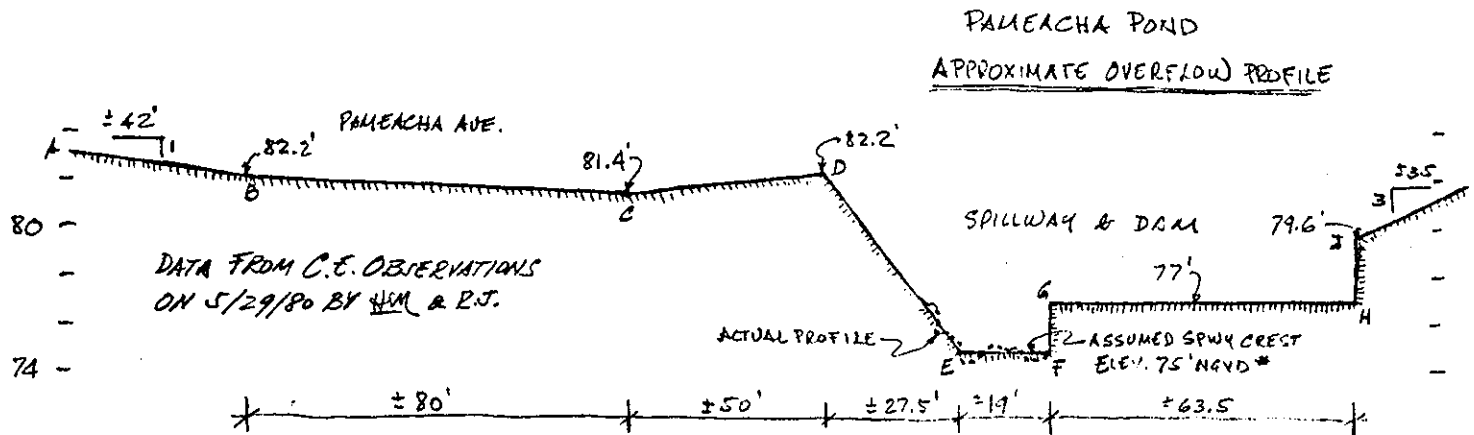
SPILLWAY (+) 19' LONG, WITH VERY ROUGH CREST (BROKEN CONCRETE) WITH VARIATIONS IN ELEVATION OF UP TO 1'. BROKEN LEFT SIDE WALL (STEPPED) NOW SLOPING APPROX. ON (+) 7.5" TO 2" SLOPE. STONE MASONRY & CONCRETE DAM. (SEE OVERFLOW PROFILE P.D-2).

ASSUME $C=2.5$ FOR THE ENTIRE OVERFLOW SECTION.

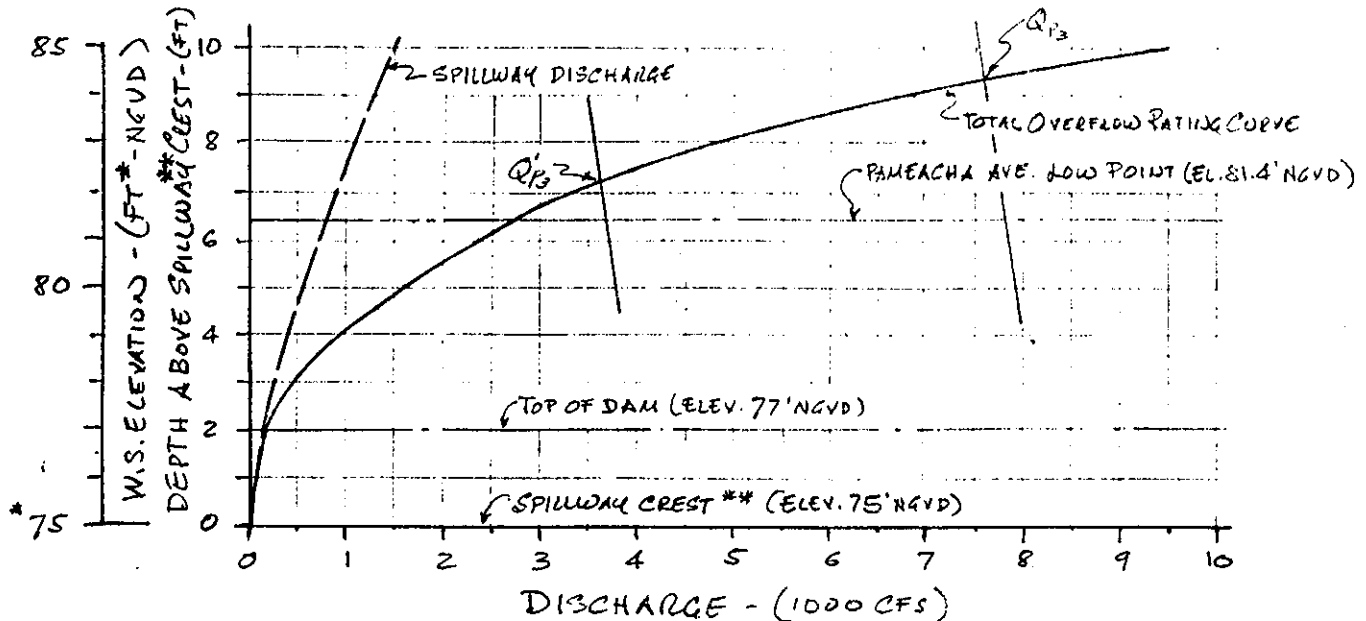
iii) PAMECHA POND DAM - OVERFLOW RATING CURVE

THE CORRESPONDING OVERFLOW RATING CURVE IS PLOTTED ON P. D-3.
